Docket No. SA-522

NATIONAL TRANSPORTATION SAFETY BOARD

Materials Specialists' Submission
Selected Results of the Nondestructive Examination of the
Vertical Stabilizer and Rudder

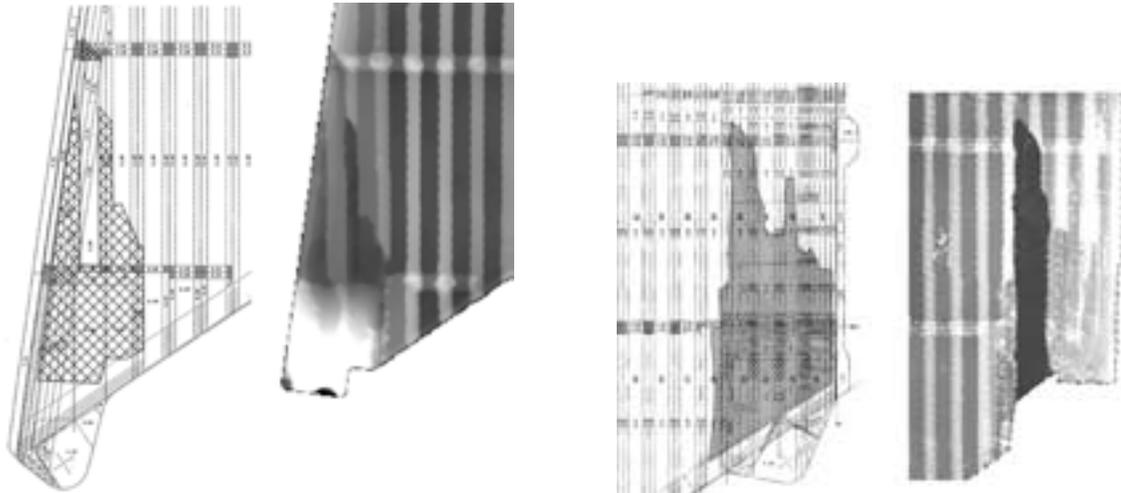
Figure 1.04 Expanded view showing delaminations at the lower end near the forward and aft spars.

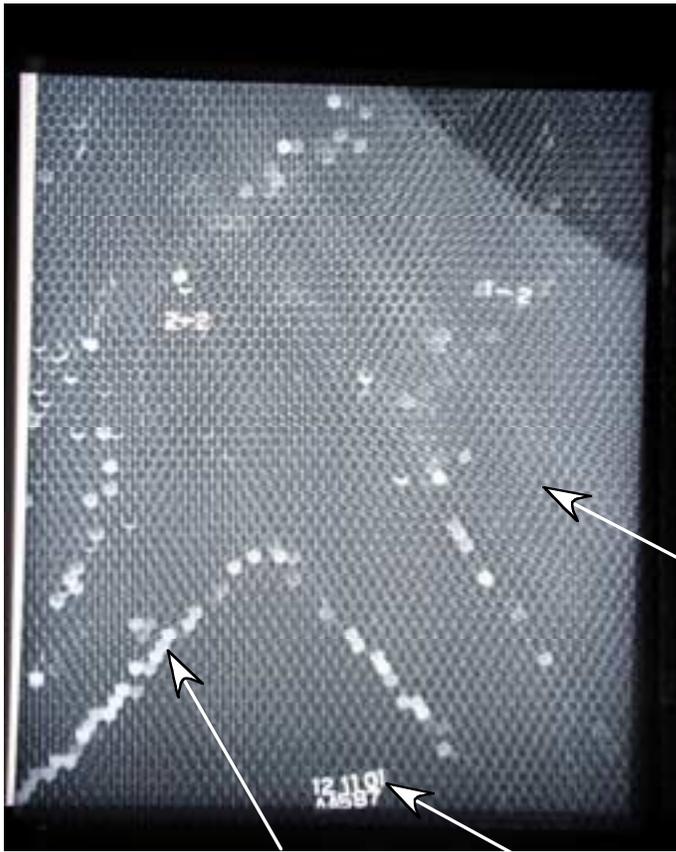
Figure 3.01 Radiographic image of water in honeycomb of rudder.

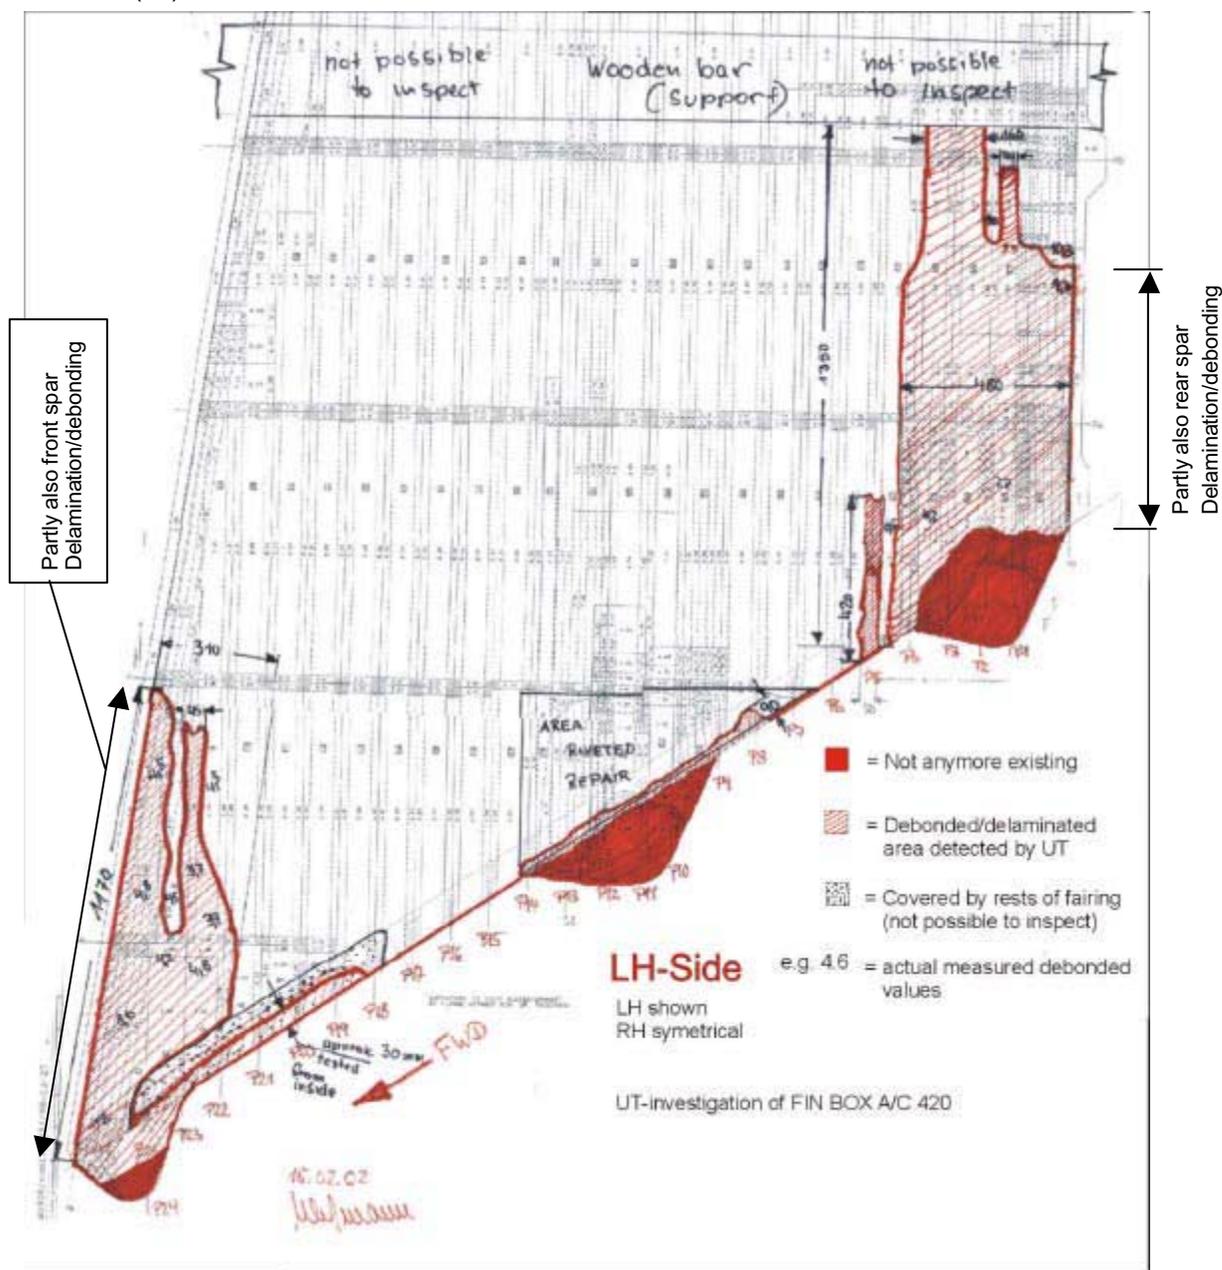
Fig.02: Test Results of Lug region from LH-side and shell above the lugs

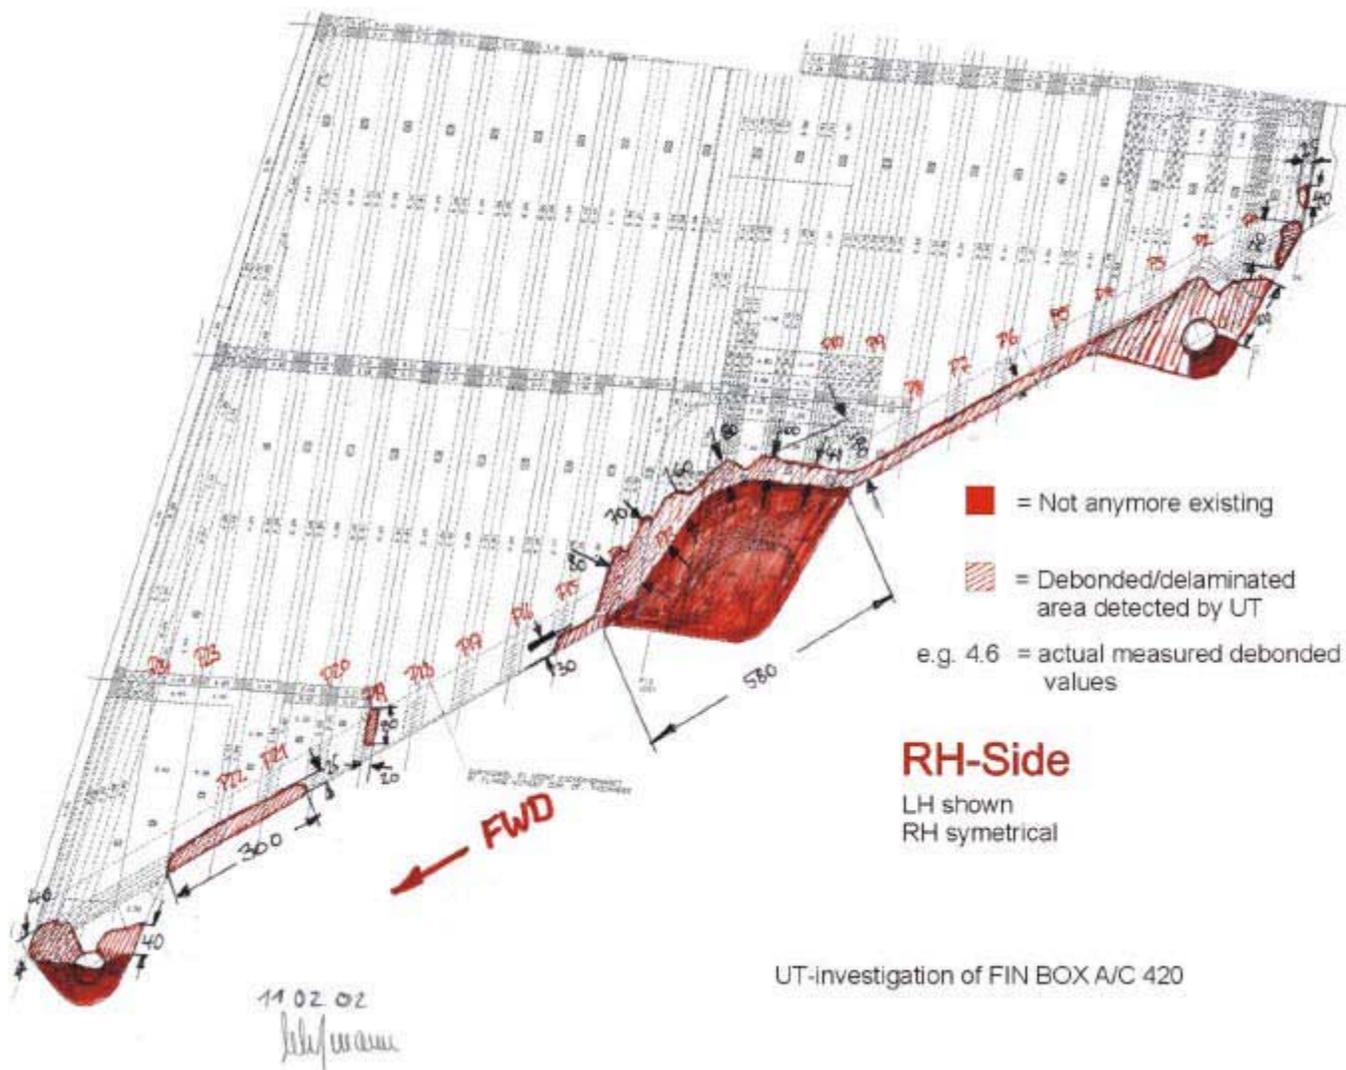
FIG. 03: Test Results of Lug region from RH-side and shell above the lugs

- (b1) Front Spar /Stiffener No. 1 (see also photo no. 1)
 ! Length Dimension of debondings between Skin and Front Spar angle are illustrated in Fig. 02/03

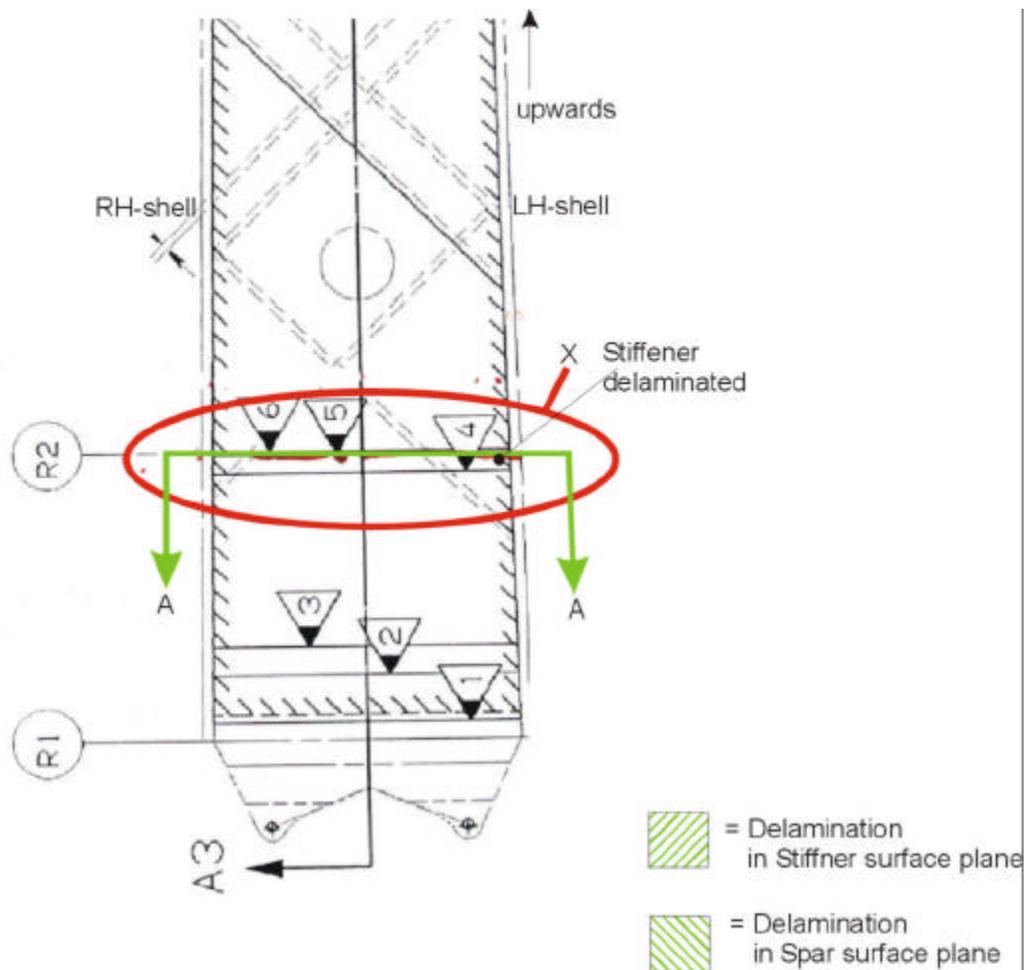
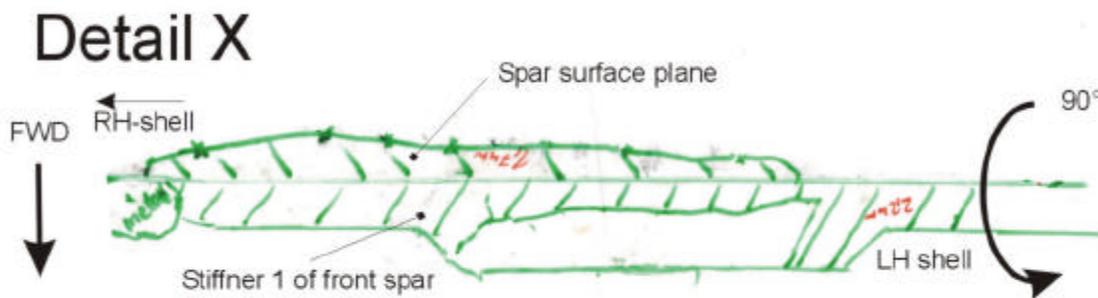
FIG. 04: Test results of front spar ; stiffener no. 1

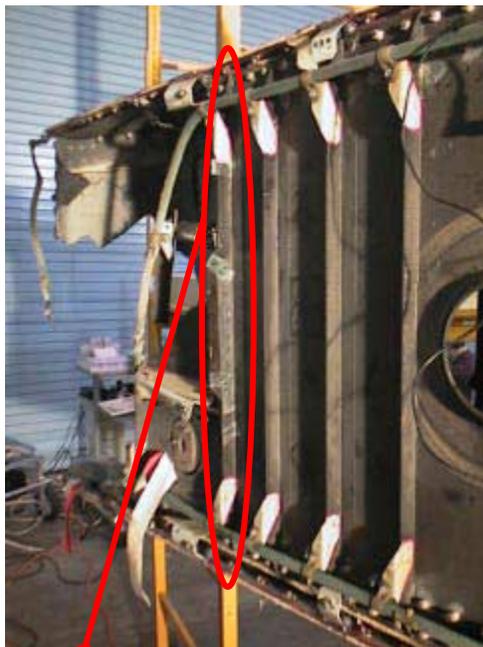
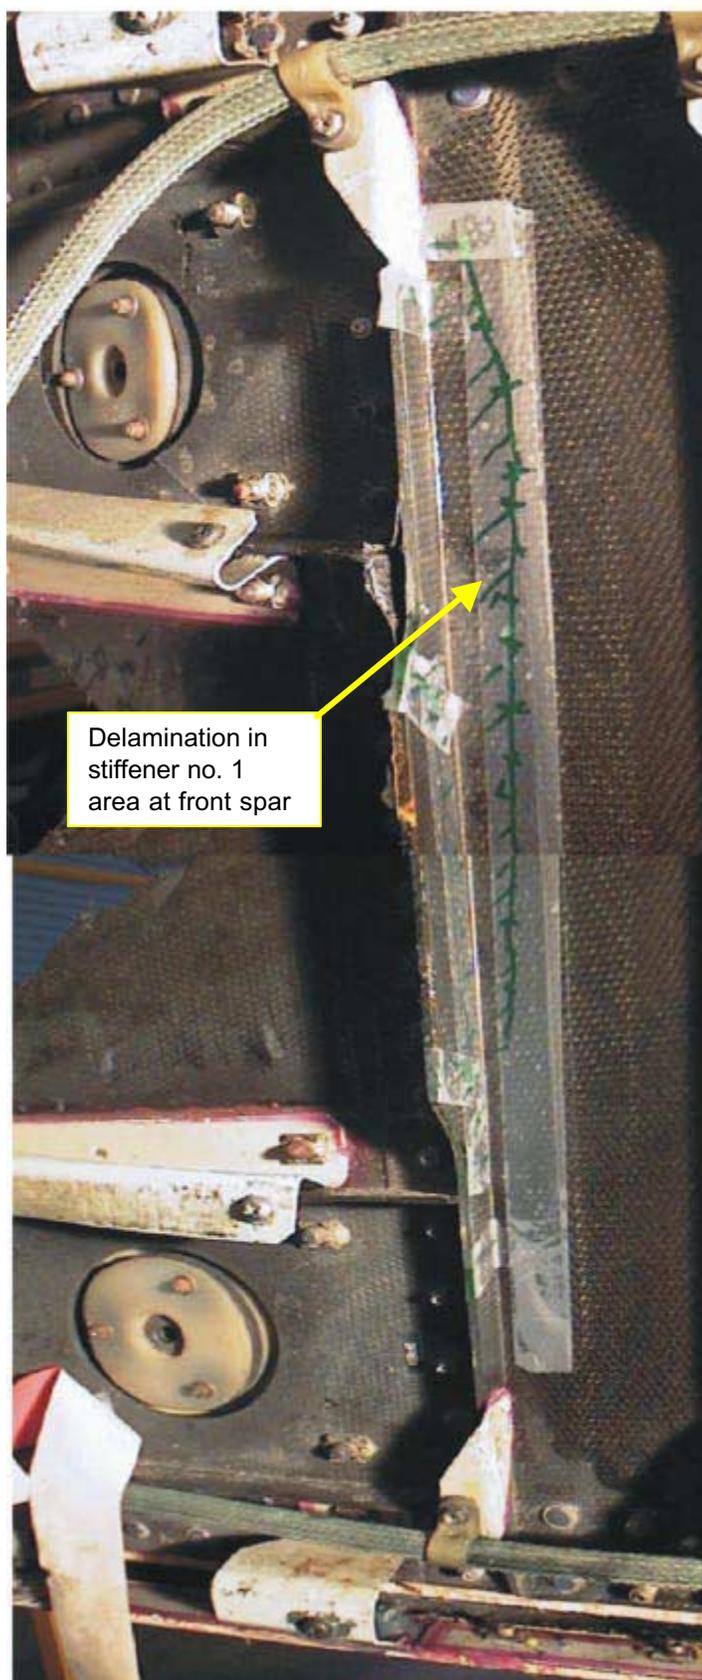
Photo no. 01: Delamination at front spar; stiffener no. 1

Delamination in stiffener no. 1 area at front spar

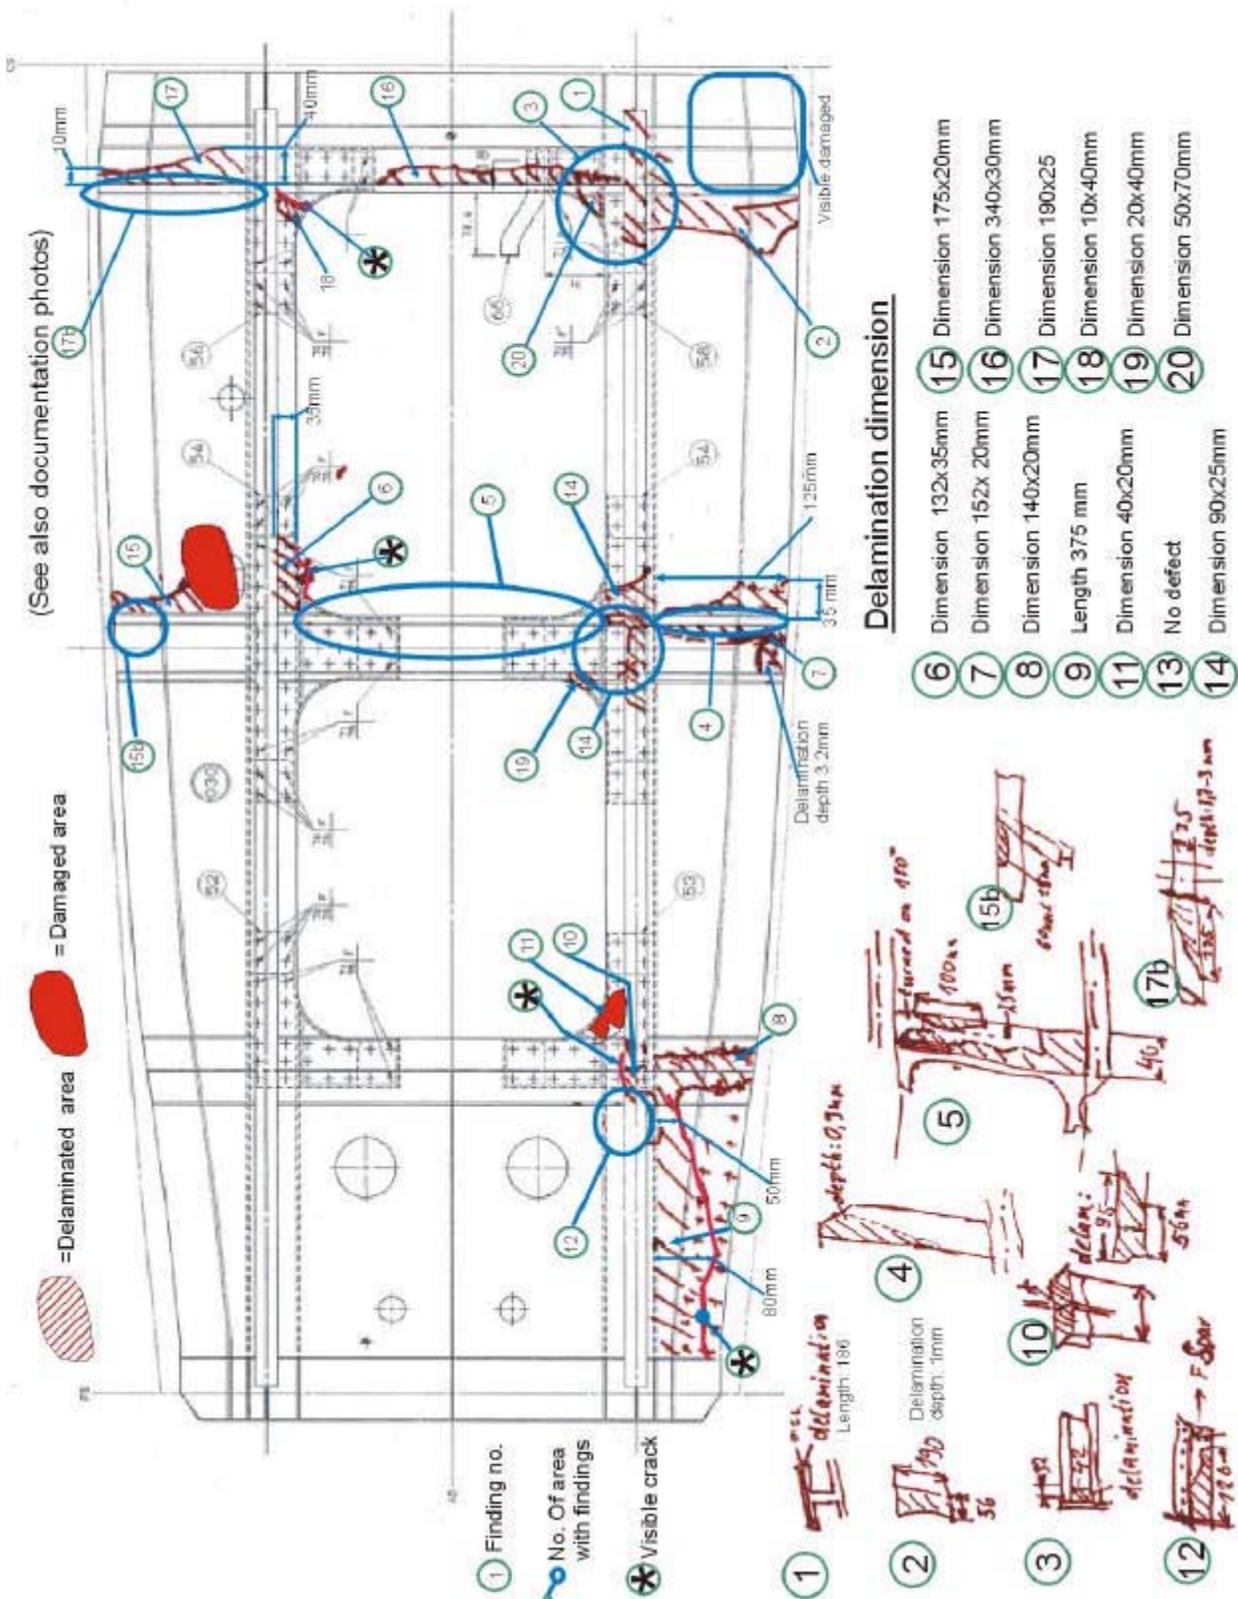
FIG.08: Delamination areas; damages in the area of rib no. 1 between center spar and front spar

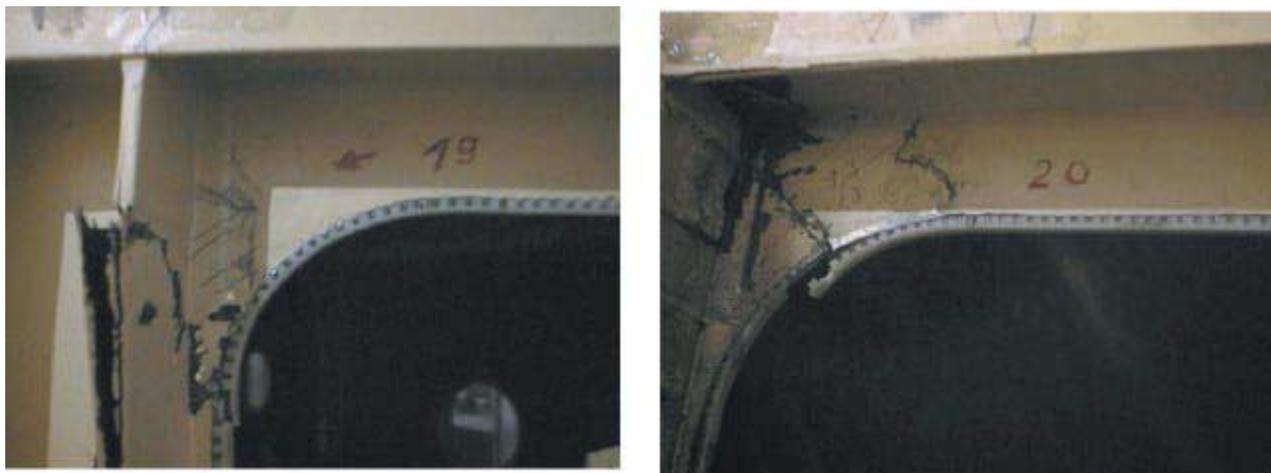
Fig.12: Photo documentaion of Findings 19-20 between center spar and front spar

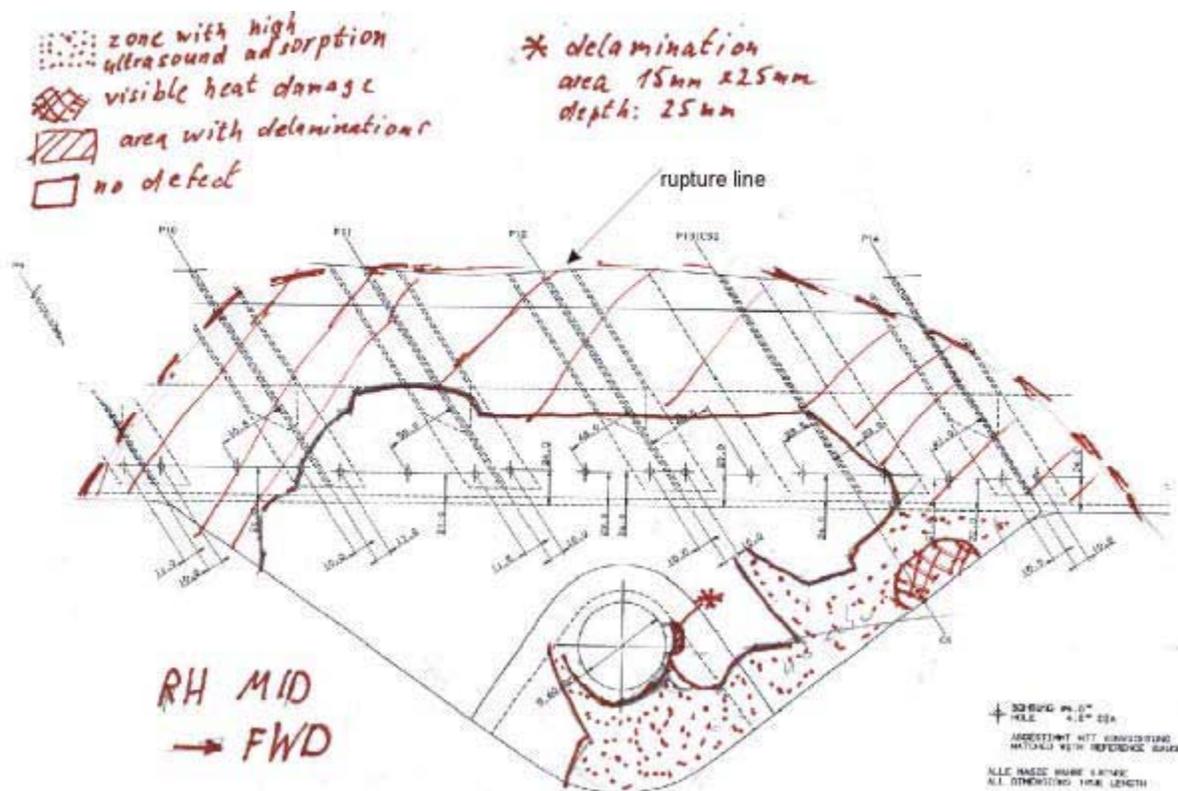
Fig. 13: Test results of UT-inspection at separated center lug / RH

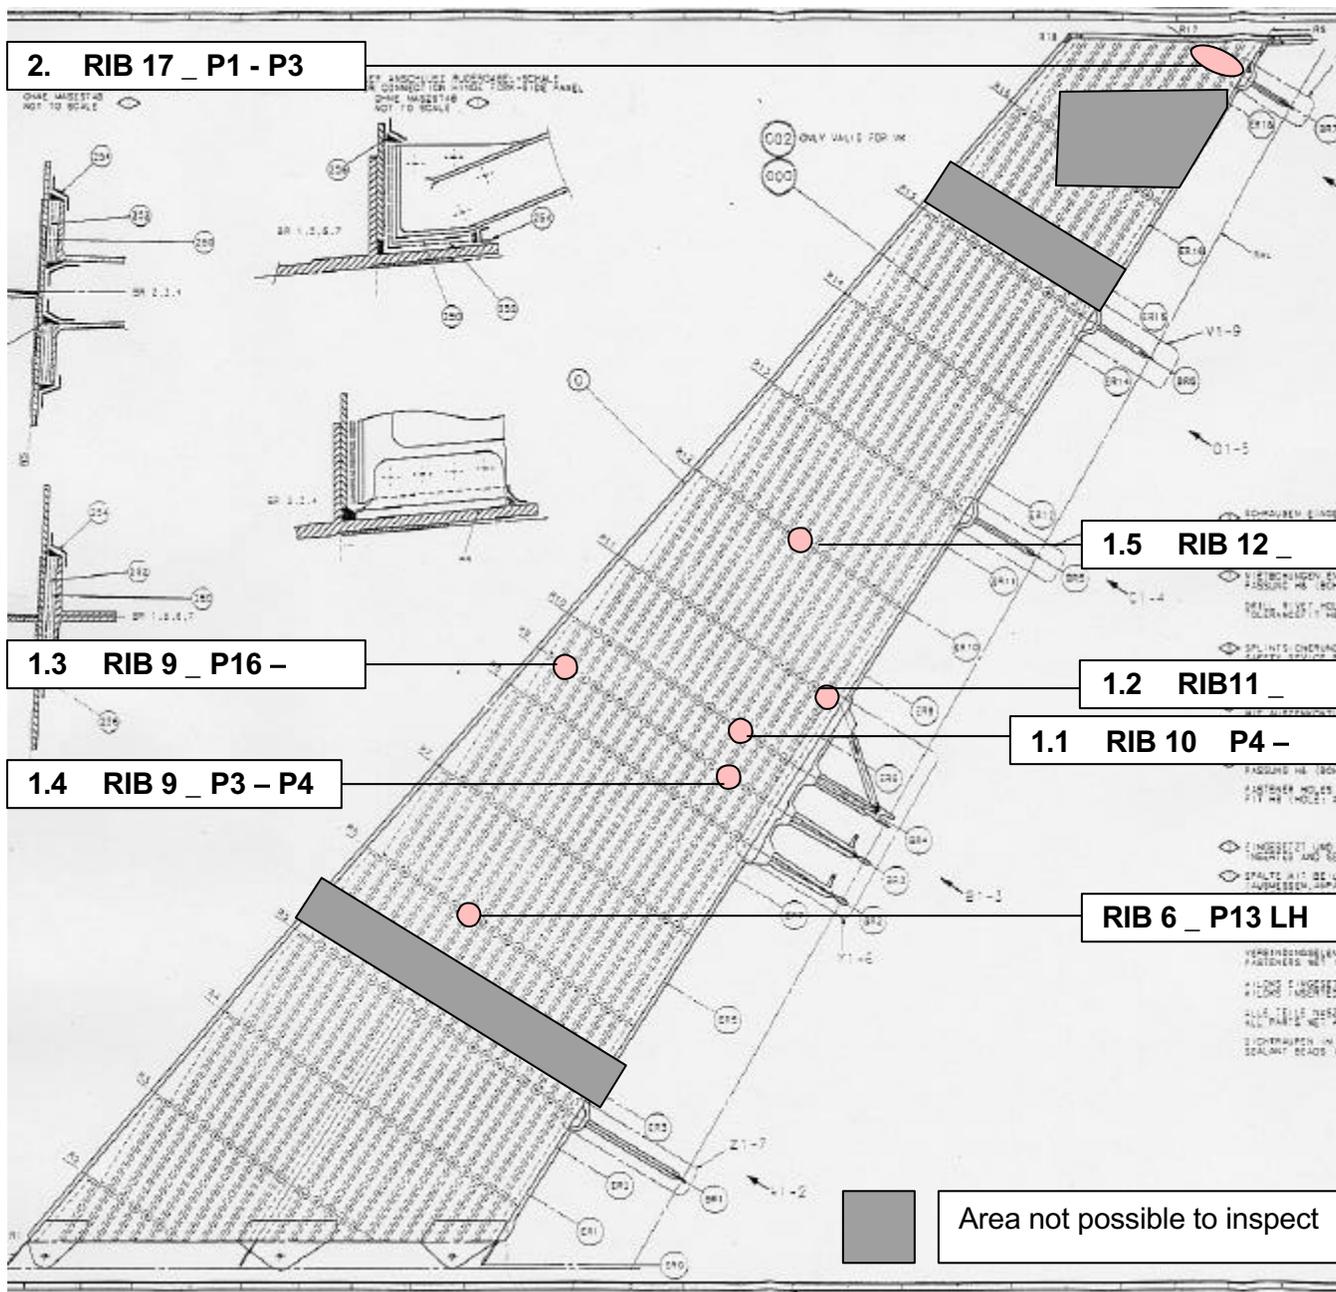
Indication vertical stabilizer A300-600 MSN420 LH

NOTE: All above documented indications are below the size to be registered in accordance with the quality requirements (see also the following detail sketches).

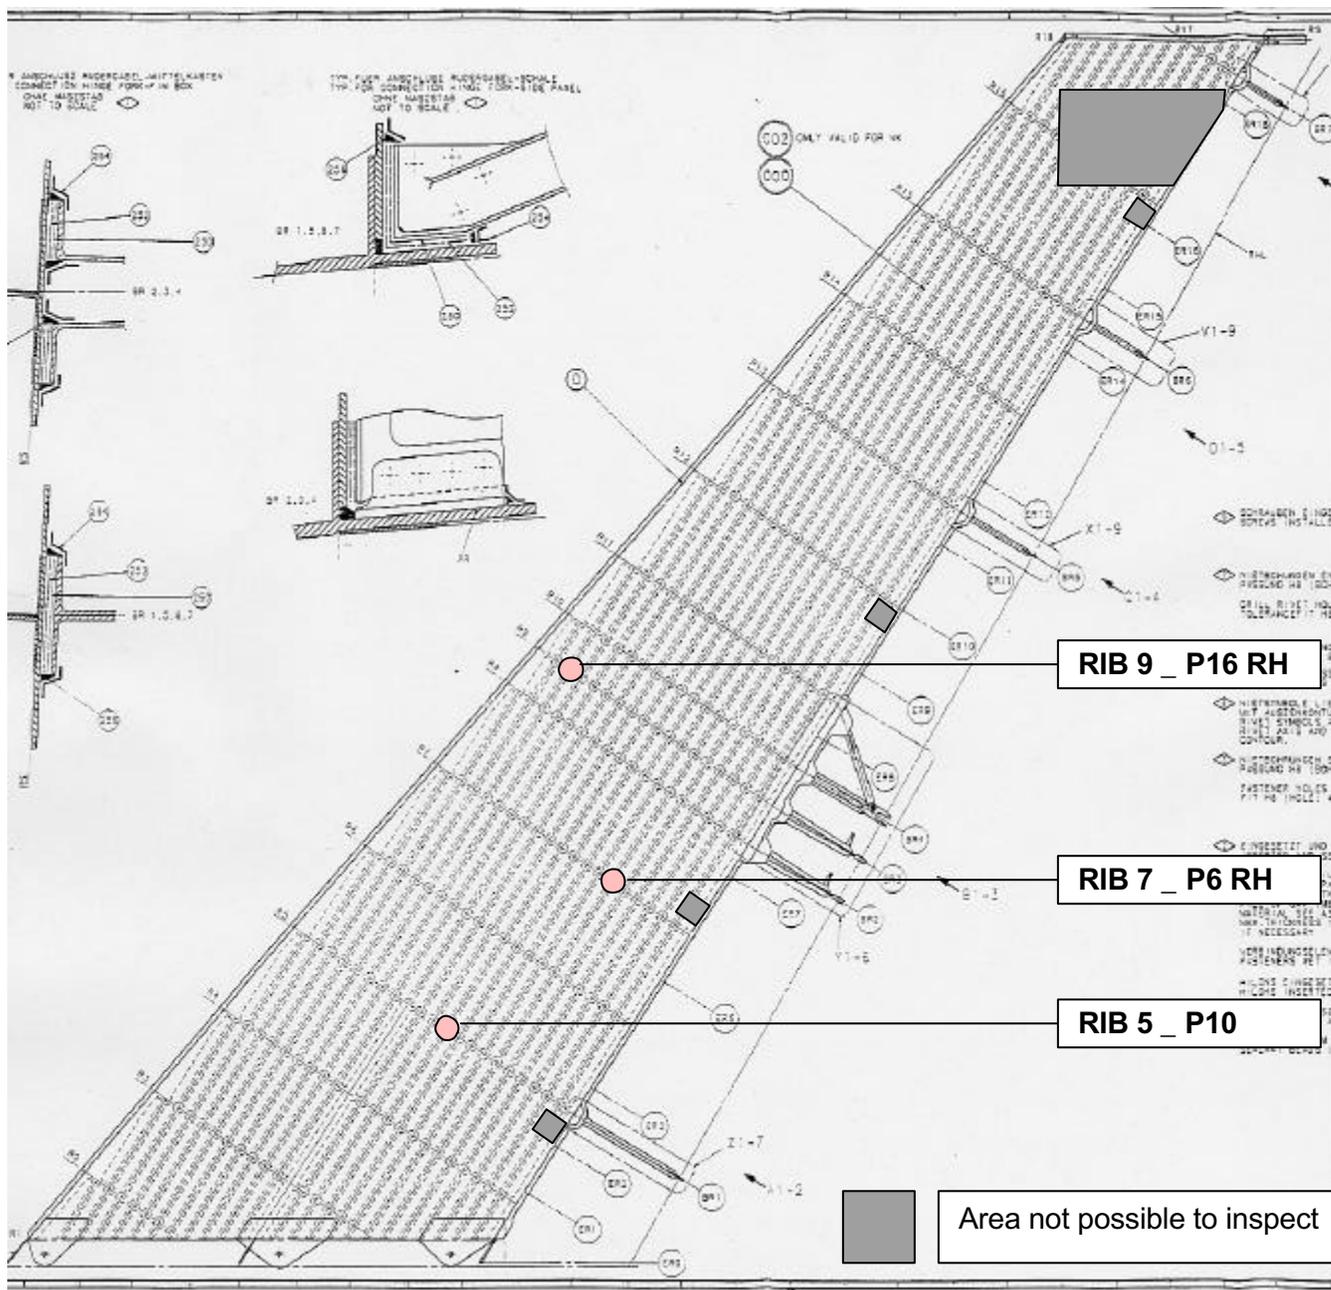
Indication vertical stabilizer A300-600 MSN420 RH

NOTE: All above documented indications are below the size to be registered in accordance with the quality requirements (see also the following detail sketches).

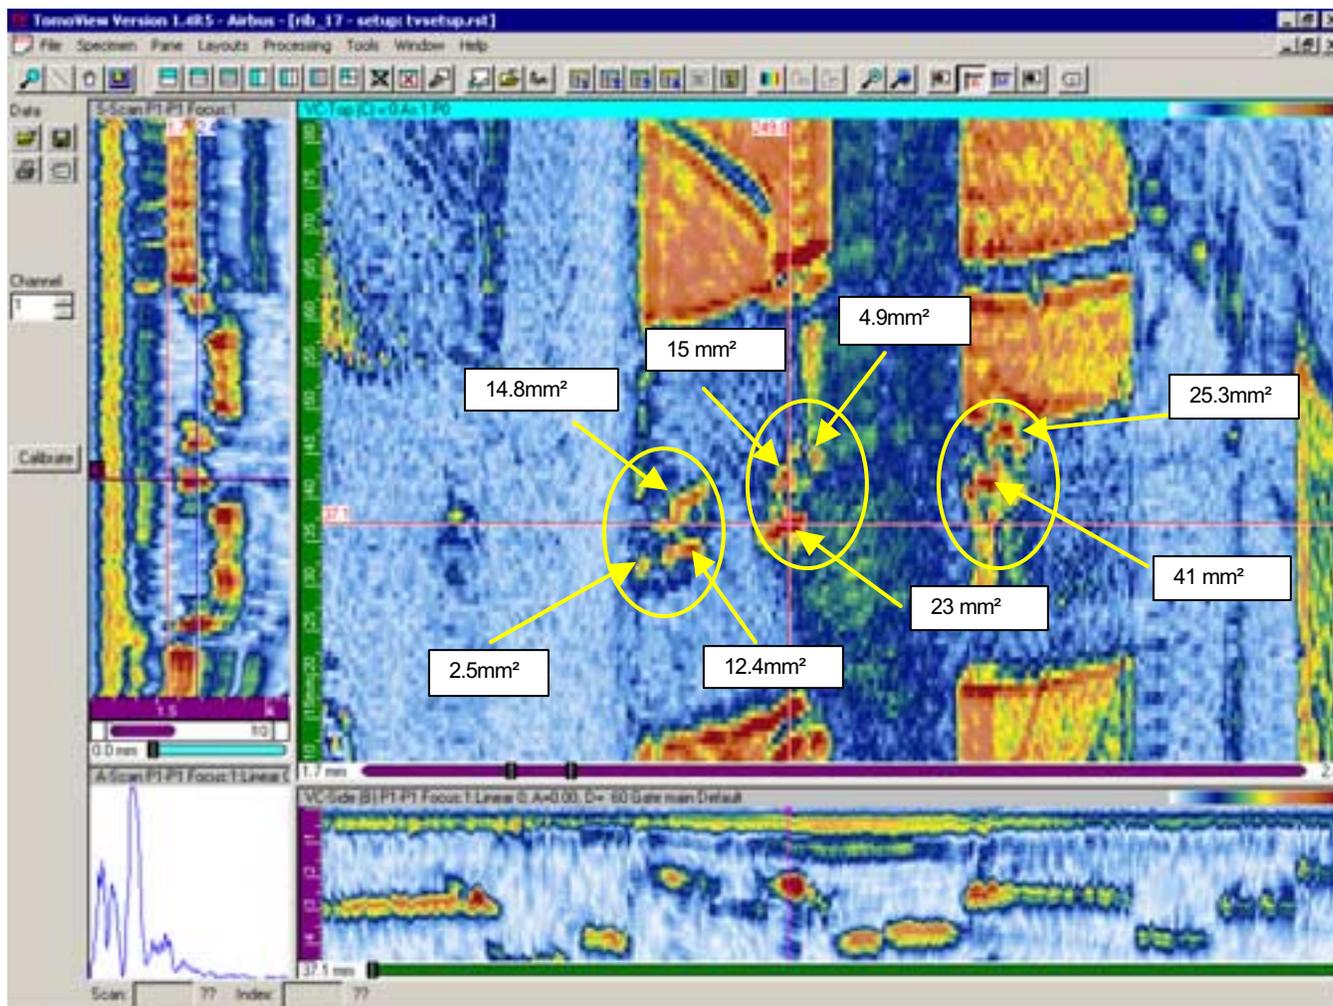
RIB 17 _ P1 - P3 LH

NOTE: The above illustrated area belongs to the quality requirement zone D, which means that a max. extension of de-lamination of 250mm² is permissible.

NOTE: All above documented indications are below the size to be registered in accordance with the quality requirements.
